Wingfield Station Level 3 Historic Building Record

for Derbyshire Historic Building Trust

8th October 2021

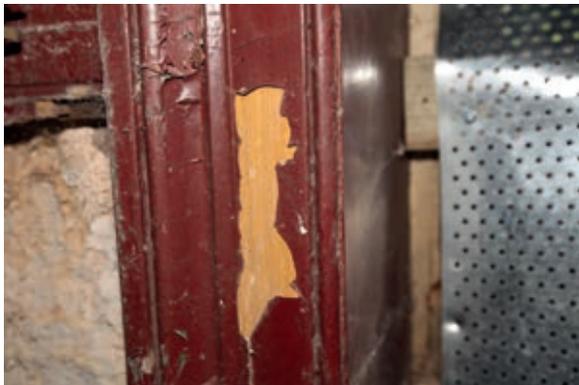
15 Top left - the Booking Hall with ghosted lines of former rails added to the walls in the early twentieth century, deeply chamfered stone fireplace to the right (originally finished with a paint effect) and red sand / lime plaster to the ceiling.

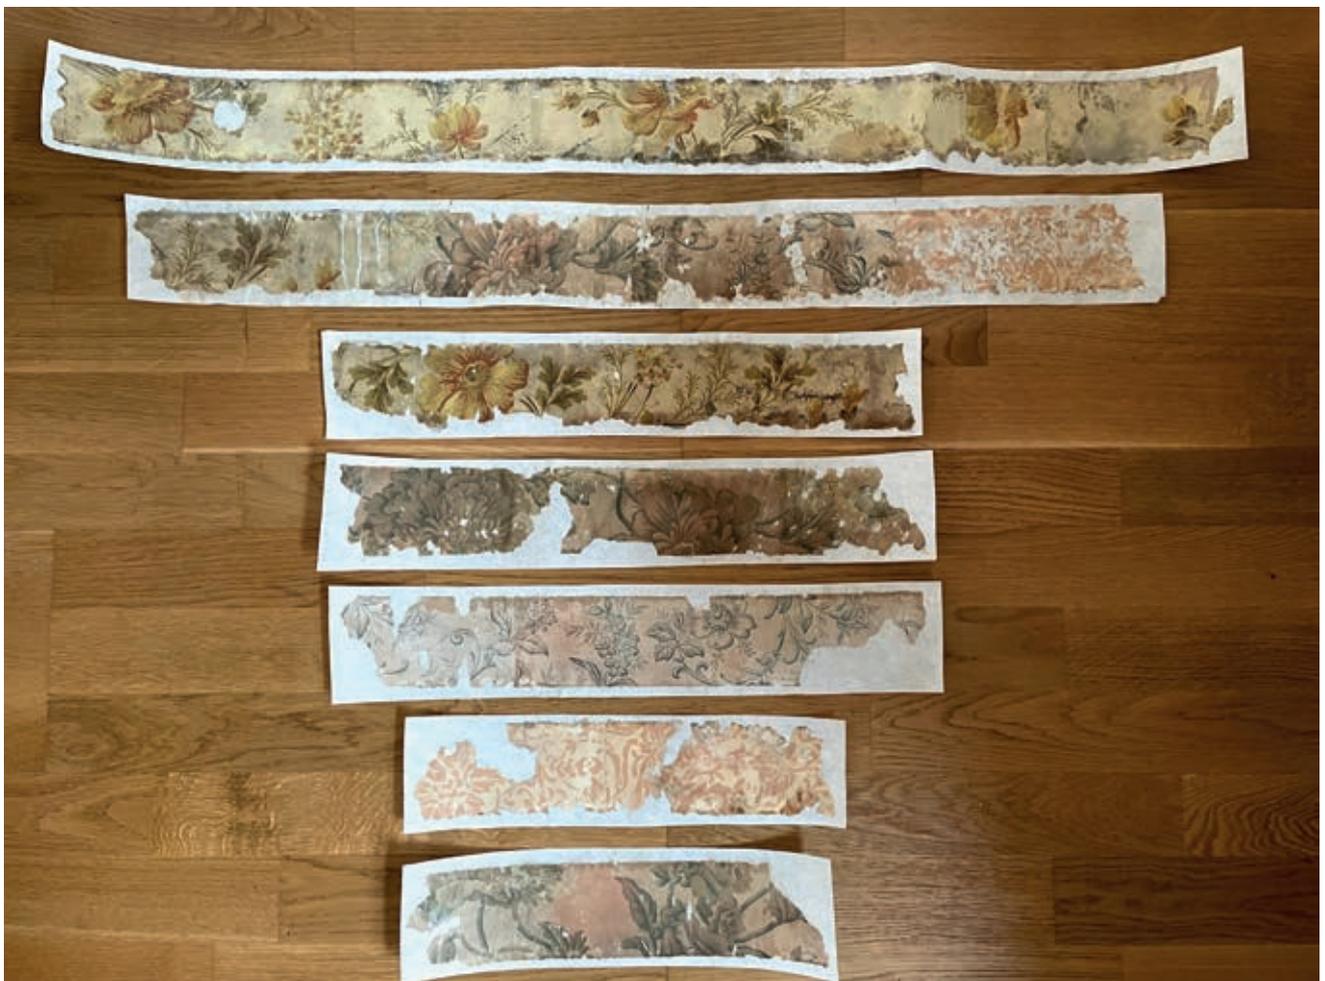
18 Wallpaper samples conserved

James Caverhill was commissioned in 2020 to remove and conserve the remaining samples of wallpaper which were found in the Ladies Waiting Room (Room 07). He found 4 different papers. The top layer is a yellow floral pattern and beneath that are two different blue floral designs on a white background. The fourth layer, which is attached to the wall and is the original scheme, is a pinky /orange floral design on a paler pink/ orange ground. Each of the layers were separated and have been conserved within the DHBT site archive.

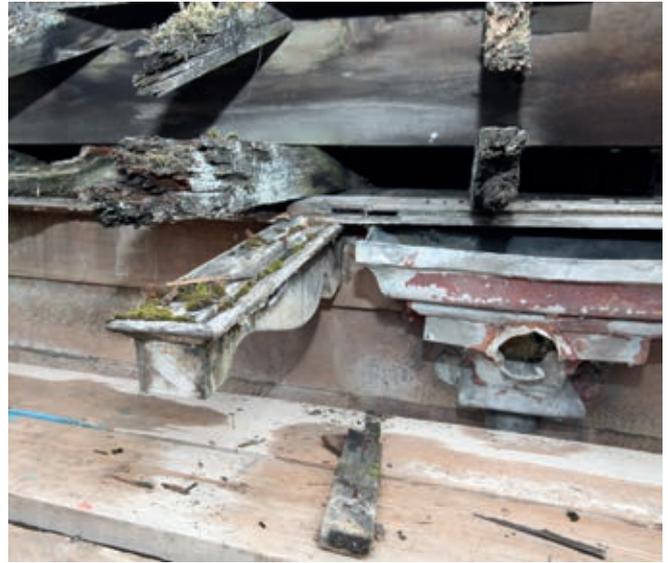
26 *Elegant lead hopper (formerly painted cream) and cream-painted eaves bracket, in-situ.*

Lead rainwater pipes, of part swan-neck shape, fixed with lead lugs, discharged rainwater from these hoppers, by-passing the lower roofs, and terminating in secondary hoppers and pipes which ran down the internal angles of the lower ranges; the lower ranges also had lead gutters which discharged rainwater in the same location and terminated in the same pipes. Many of these pipes have been replaced in cementitious-based pipe, with some later cast-iron sections remaining and some fragments of beaded hollow-roll lead pipe above and below the lower eaves. A supplementary cast-iron pipe is found on the southern wall of the lower range, a soil-vent pipe, serving the toilets. The later Goods Warehouse, however, may have originally started out with cast-iron gutters and swan-neck, cast-iron rainwater pipes.

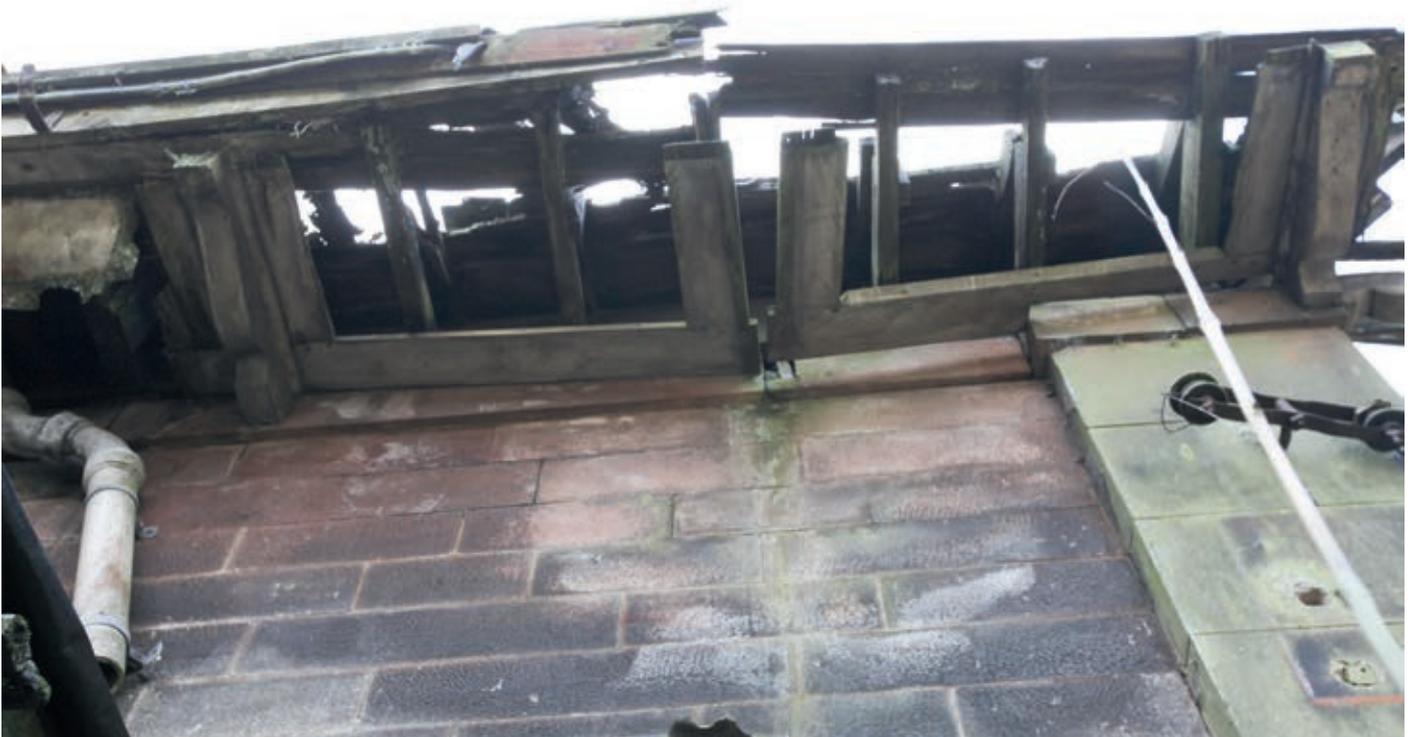
Ext_22 eaves to main roof north soffit, with timber panels IS, missing lathe-and-plaster infill to soffit

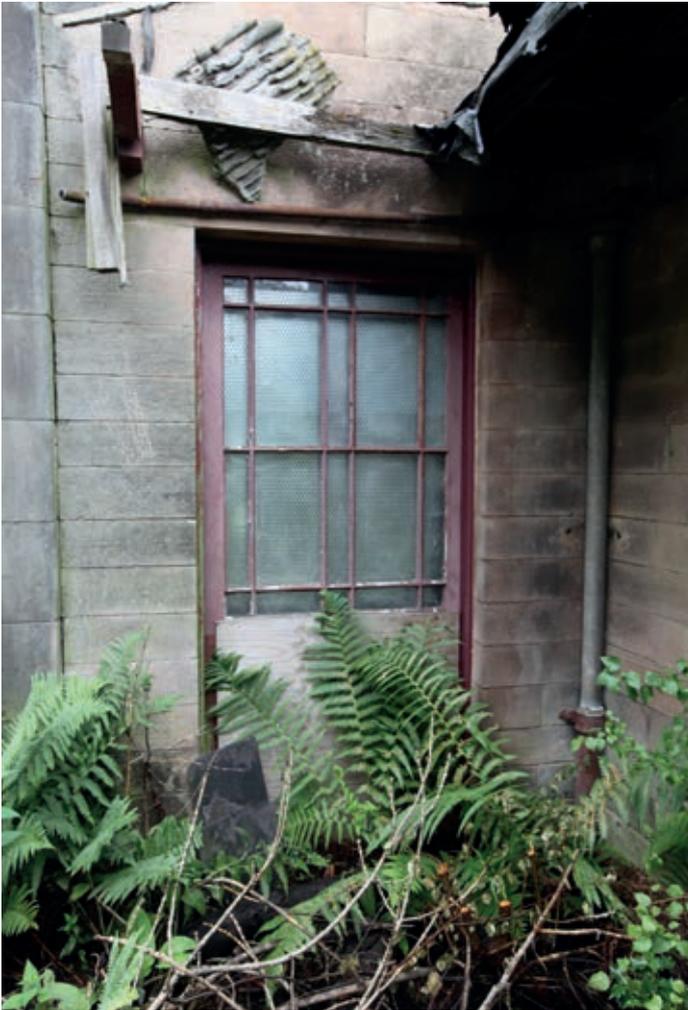
Ext_47 platform door to south with margin lights IS

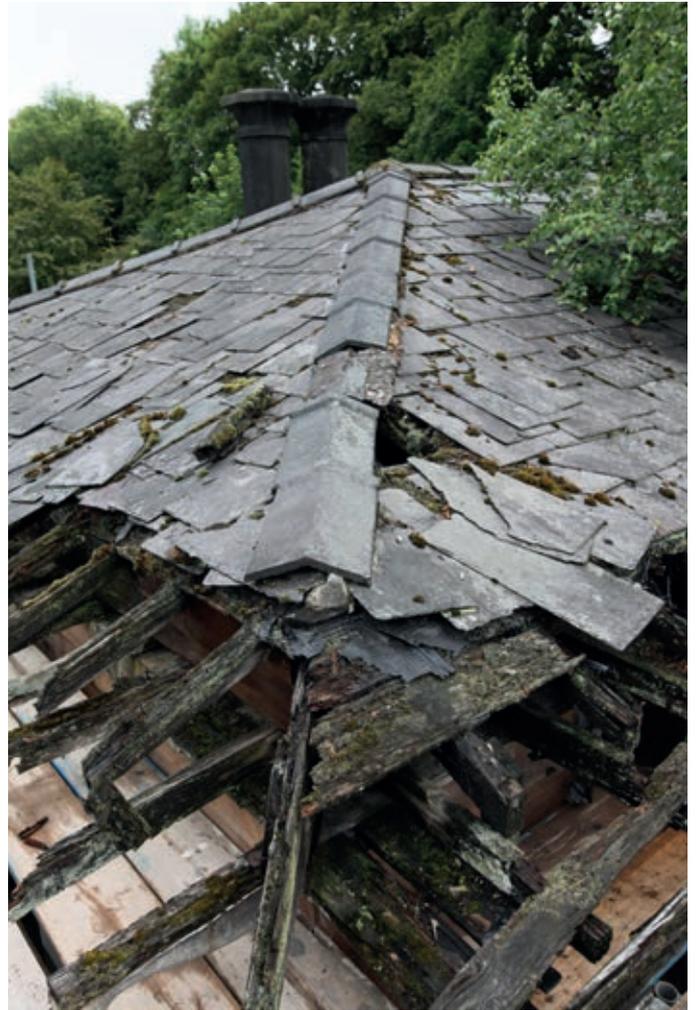
Ext_39 main roof - replacement Welsh slate and clay hip tiles

The present roof to the central 'pavilion' is Welsh slate, laid in even courses, with blue clay hip and ridge tiles. These are not the original finish. Photographs show clearly that the previous hip and ridge details were lead-covered, wood-cored rolls. By 1973 the lead-covered rolls on the hipped roofs had been replaced with clay tiles. The clay tiles are a relatively crude detail for a very refined classical building.

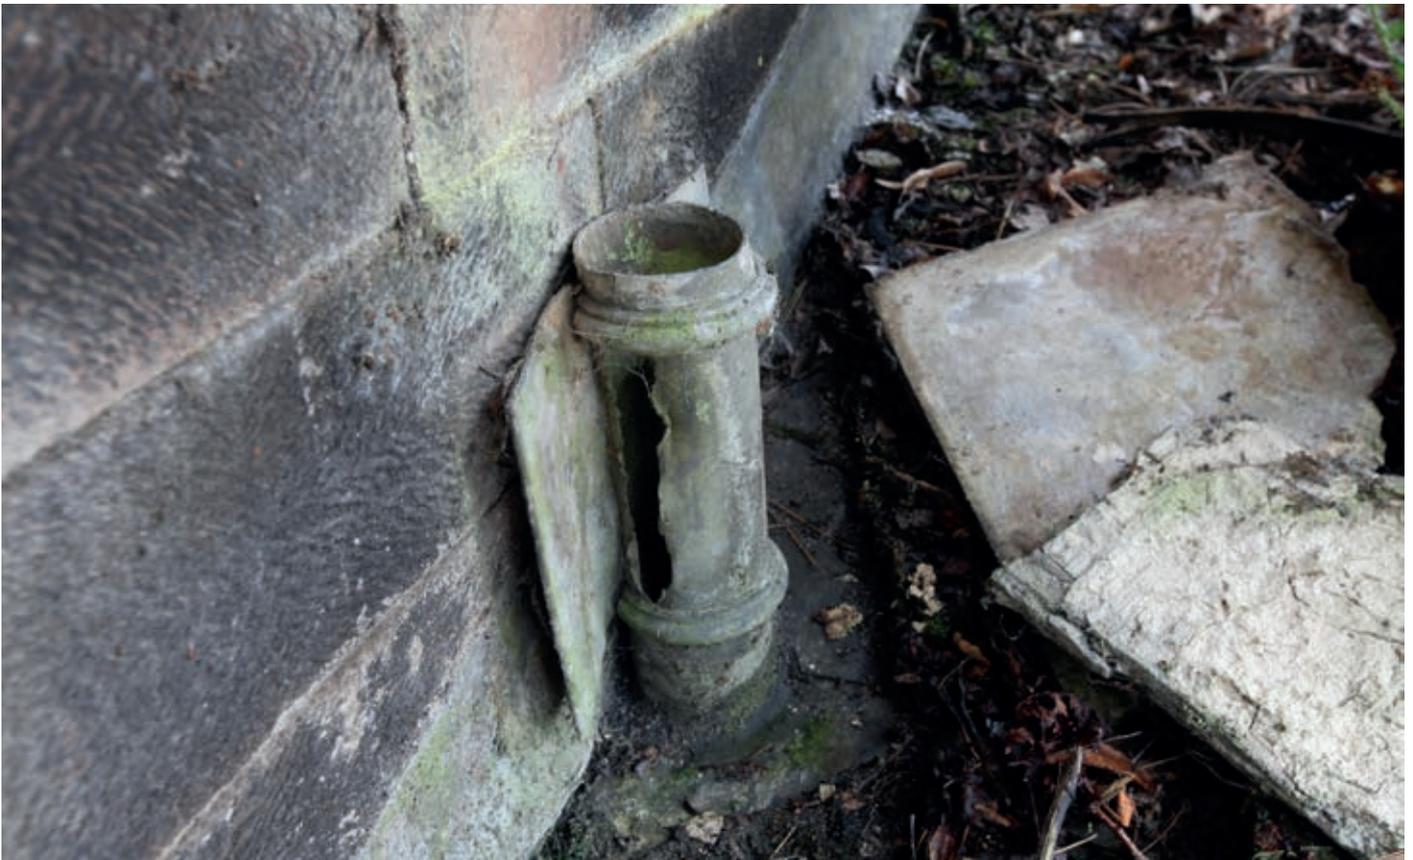
Ext_30 lead 'collar' to rainwater pipe - north east side of main roof- the sleeve is slotted through the slate roof of the lower wing

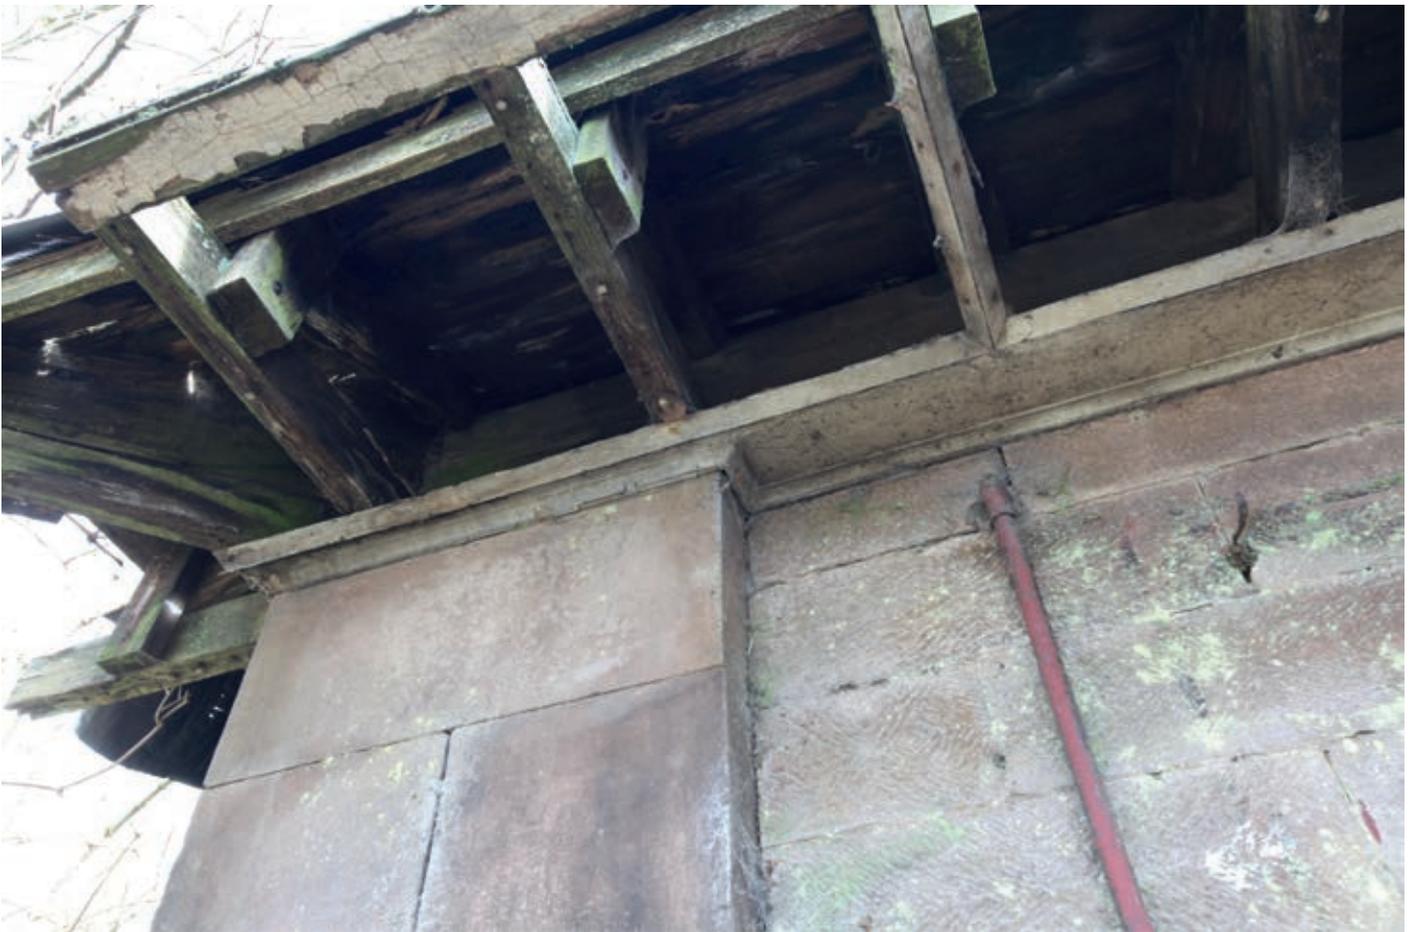
Ext_26 eaves soffit to northern wing, with original scotia moulding and later triangular beads; lathe-and-plaster missing

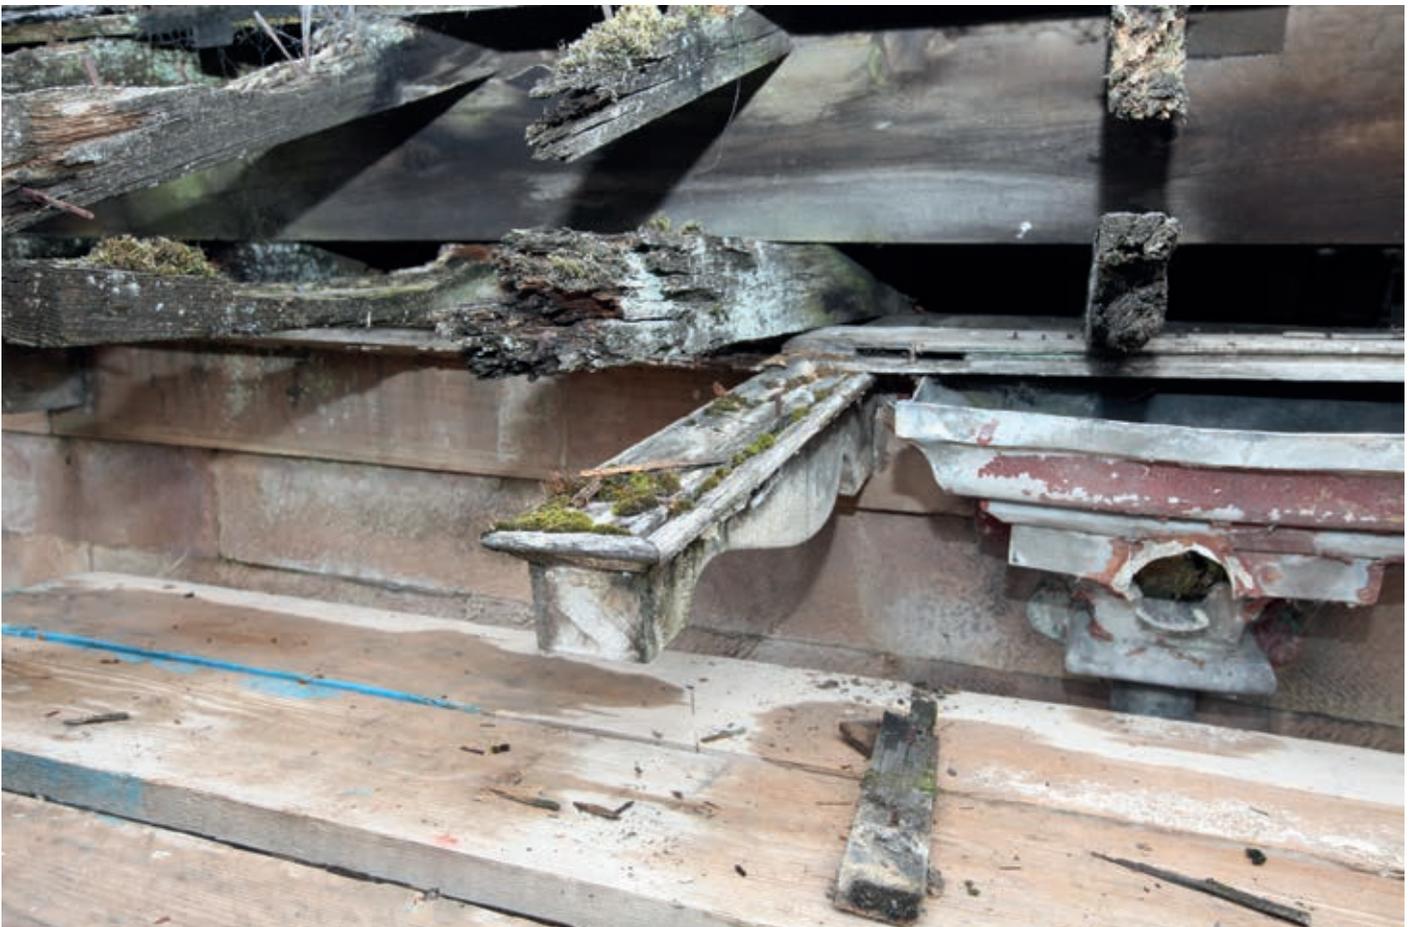
Ext_35 Eaves detail to main pavilion roof - decorative lead hopper and timber eaves bracket, IS, both originally painted cream

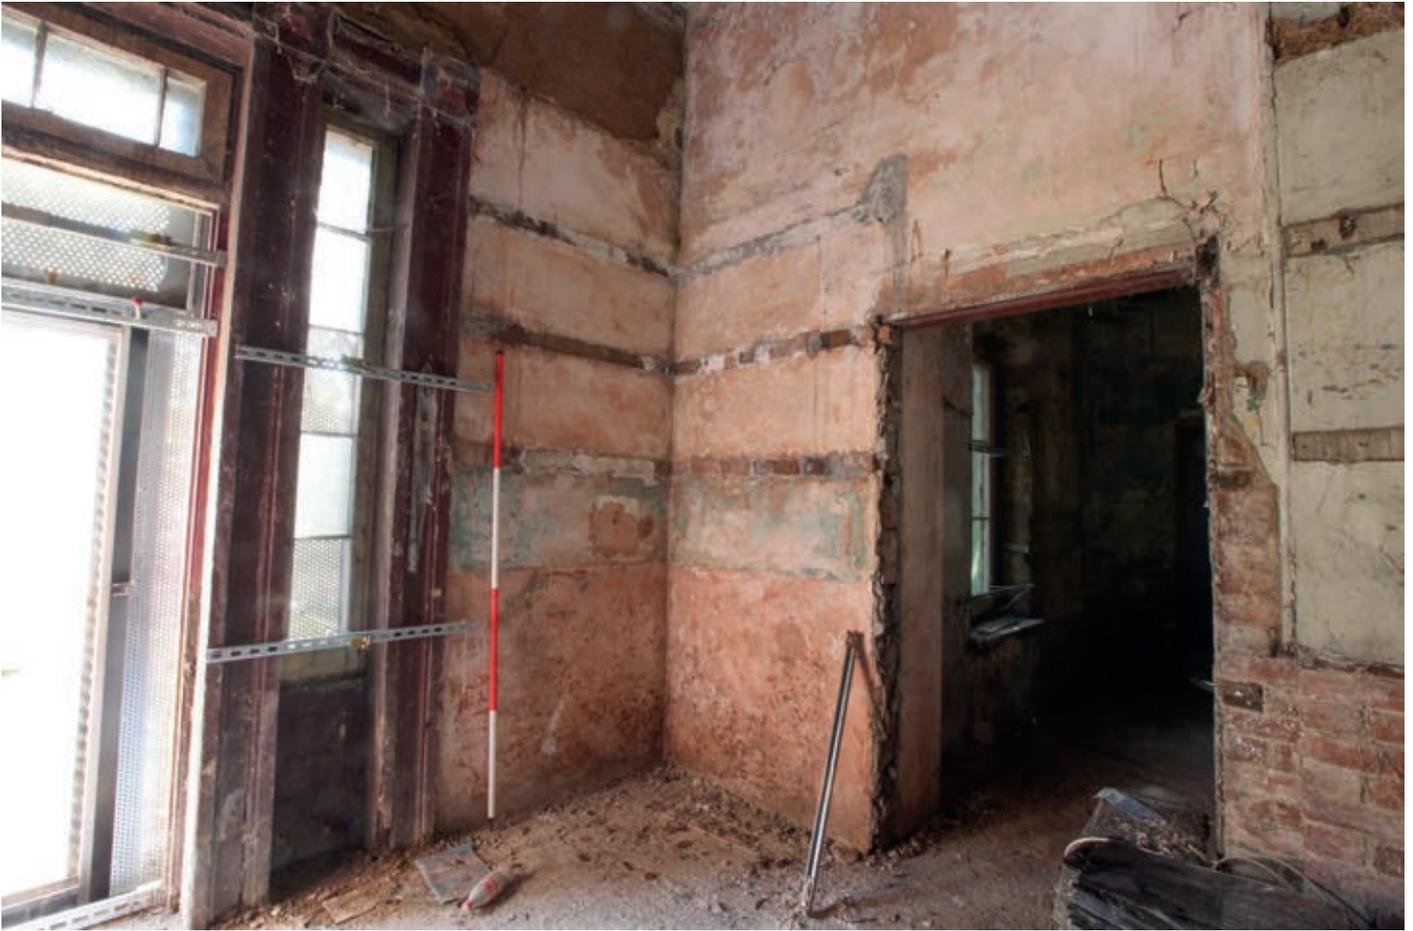
04_5 south east corner to forecourt, dado panels replaced in gypsum plaster, early C20 rails missing

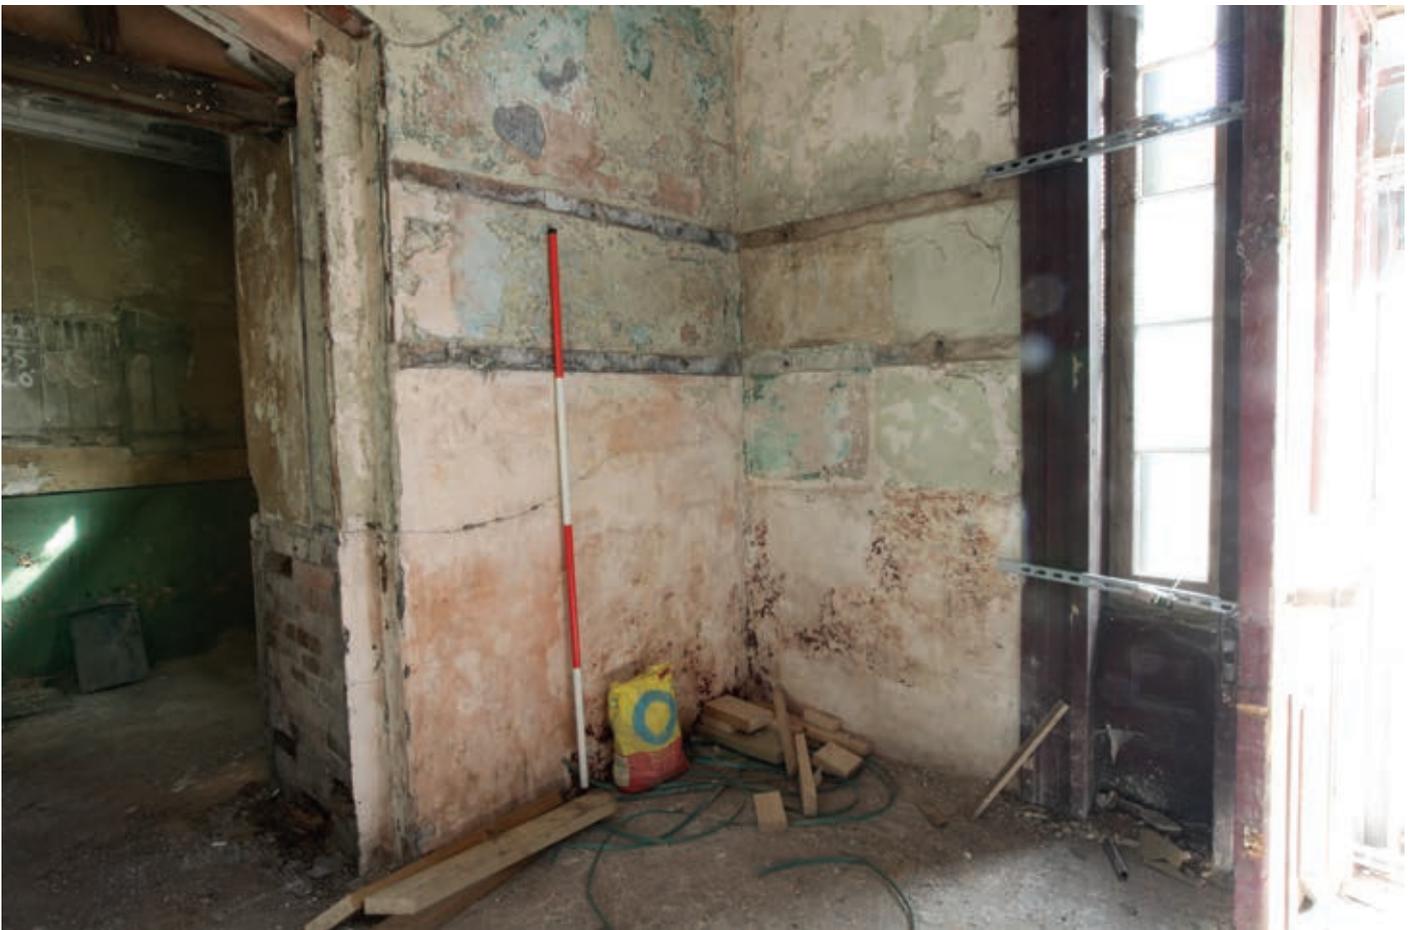
04_6 north east corner to forecourt, dado panels replaced in gypsum plaster, early C20 rails missing

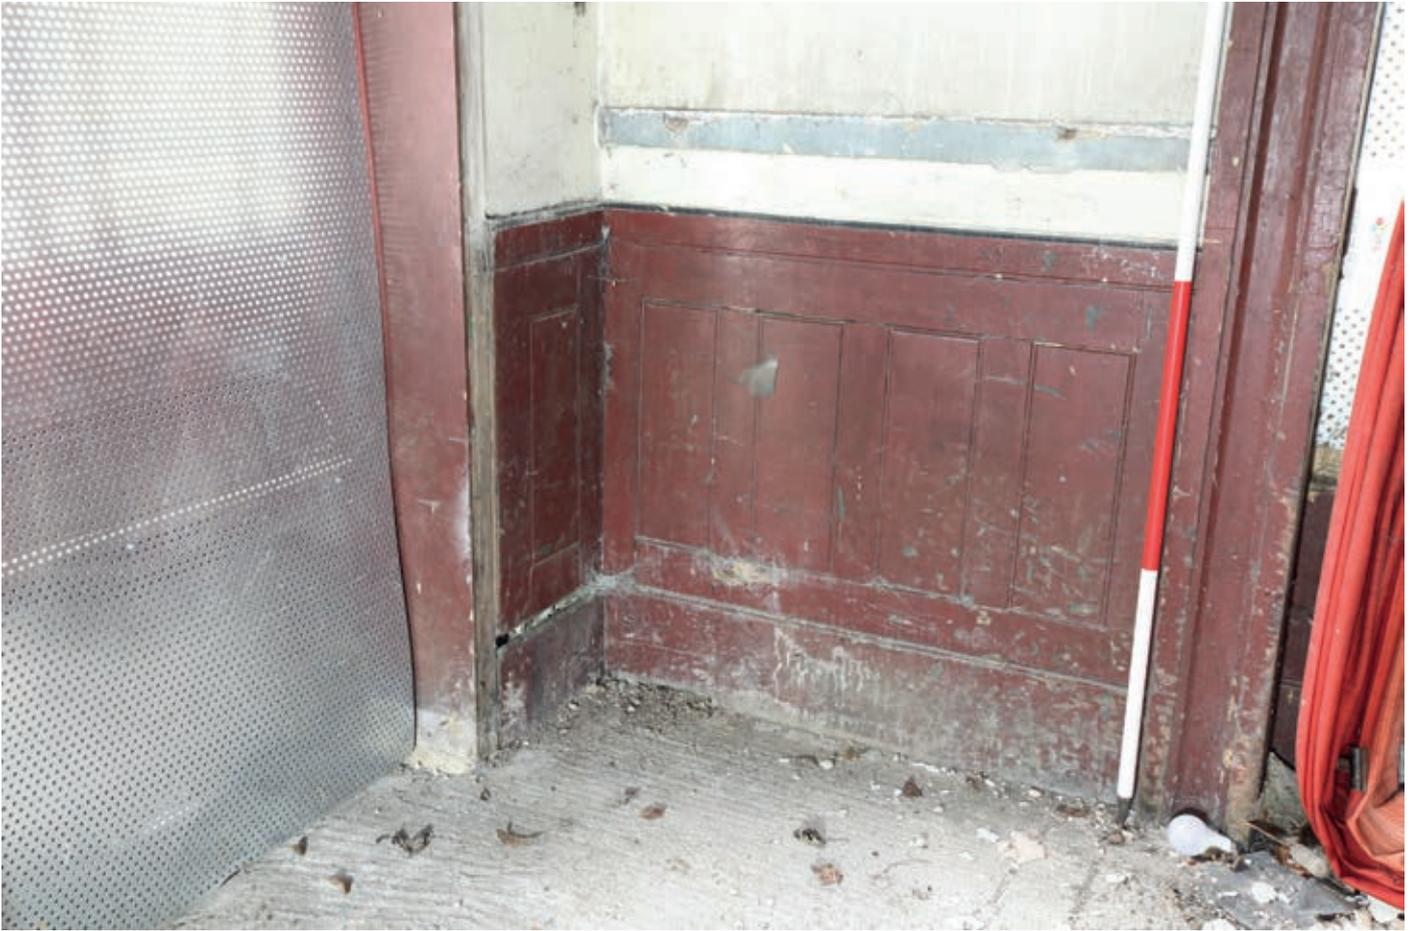
04_7 south west corner to platform, dado panels flush IS

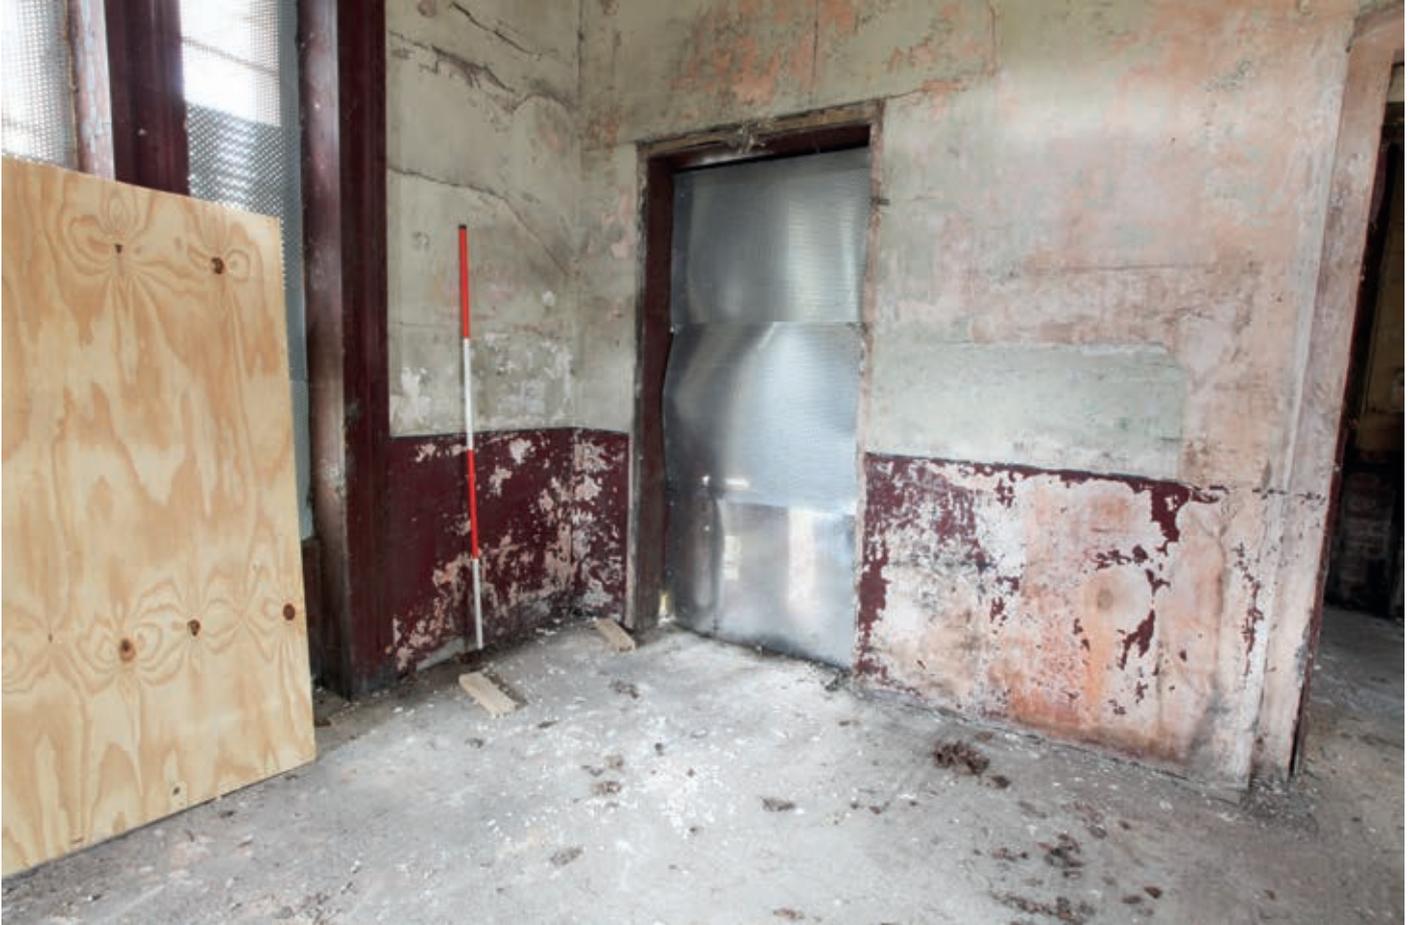
04_8 north west corner to platform, dado panels replaced with paint effect

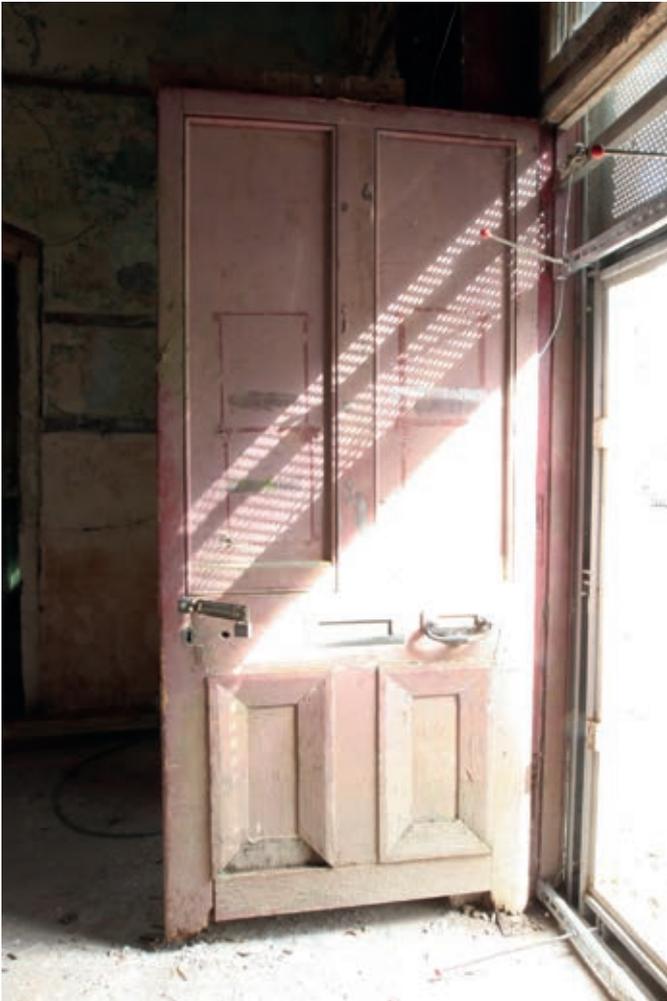
d01_2 entrance door, with diminished stiles, margin lights removed

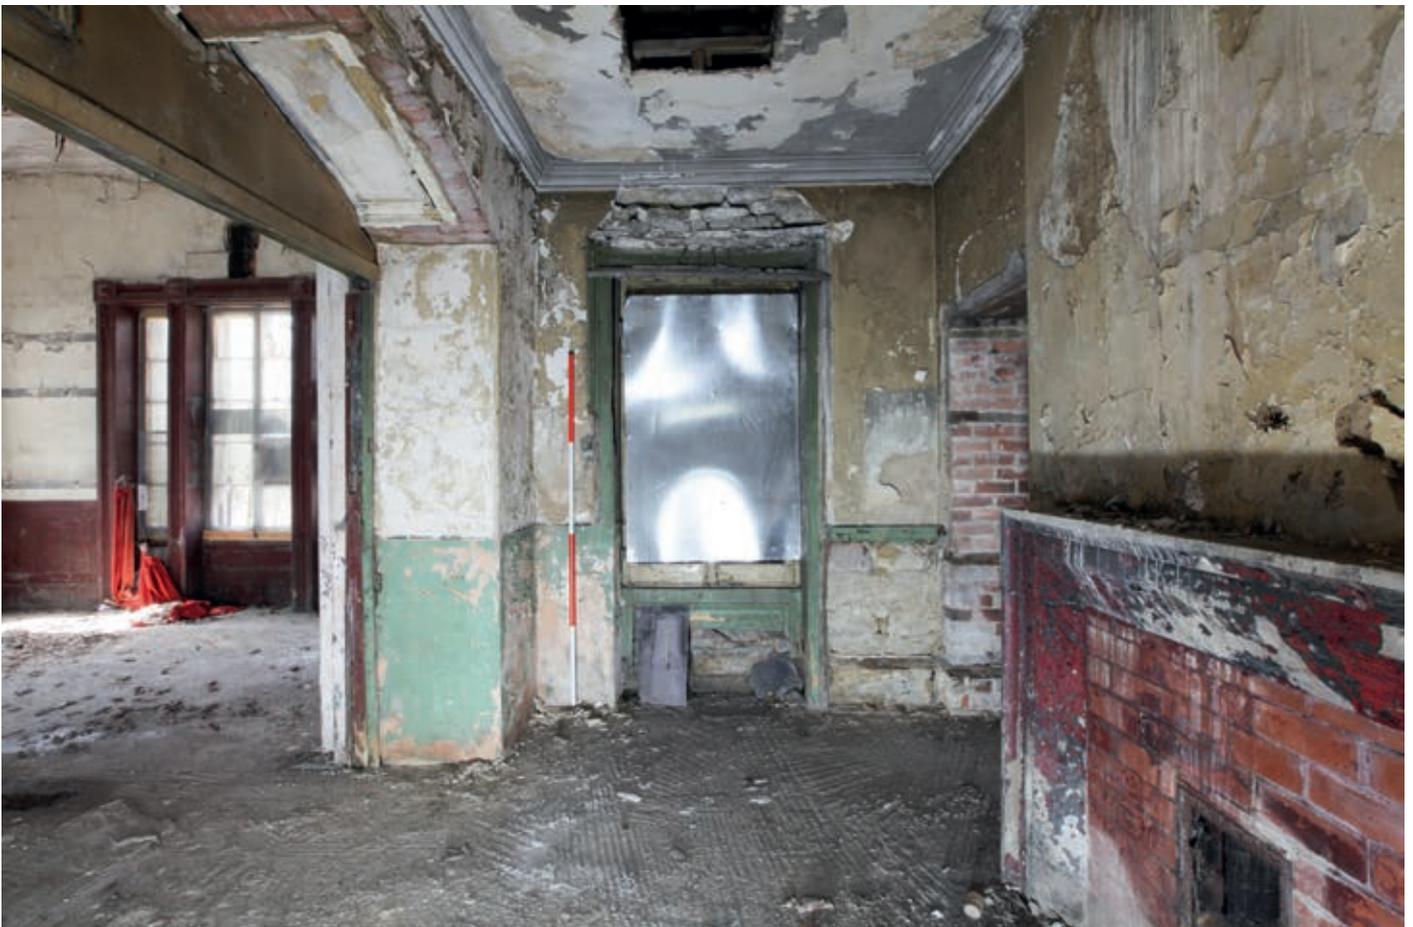
03_2 - western part of ticket office, French window with panelled apron, dado panel missing, cornice IS

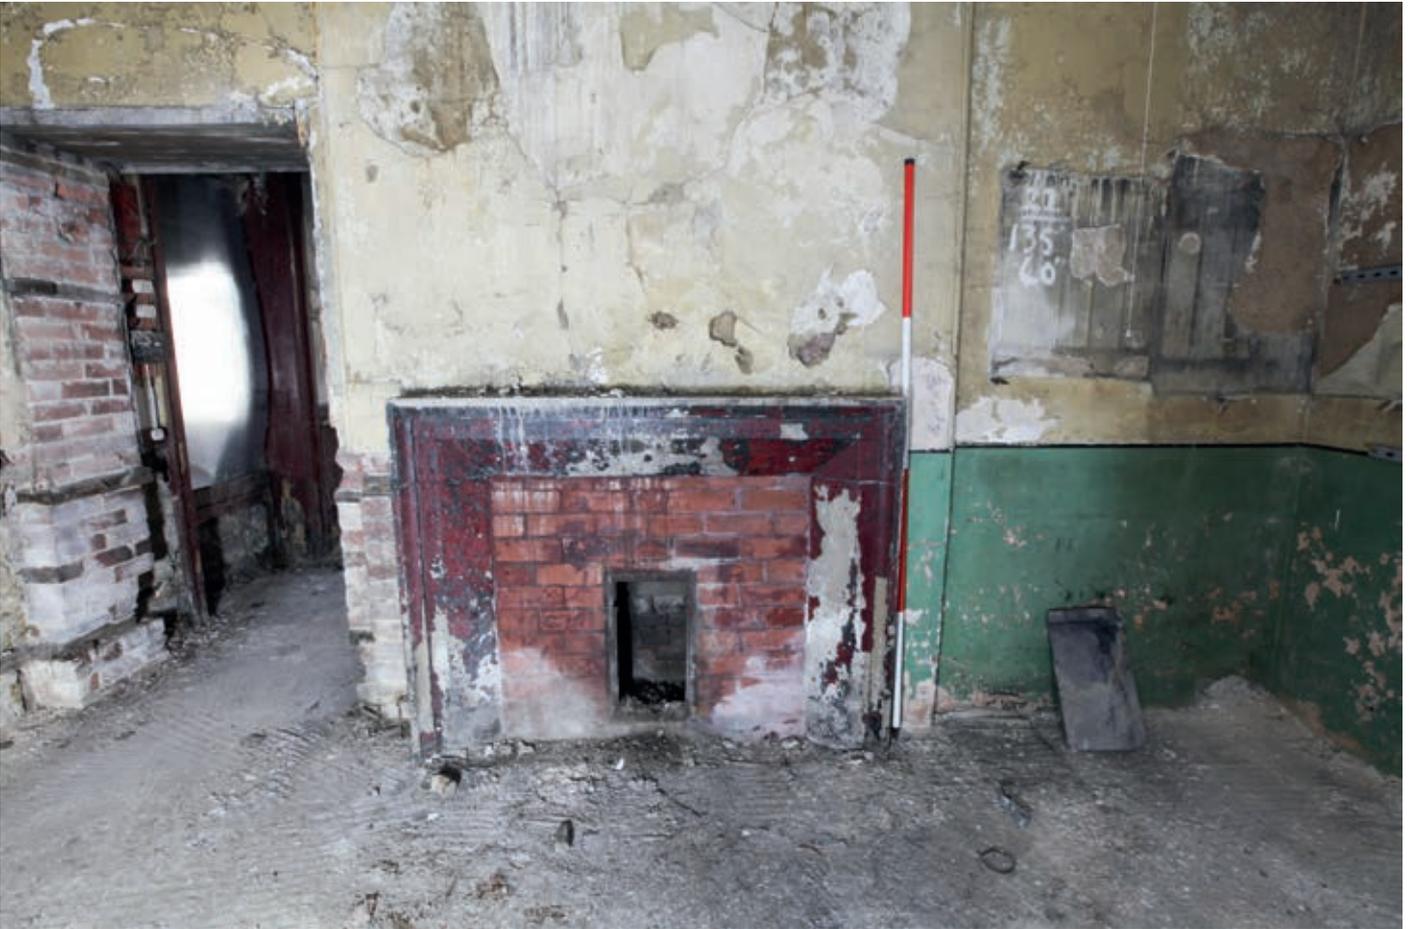
03_3 stone surround to Ticket office fireplace, chamfered with masons mitres and later brick infill to hearth

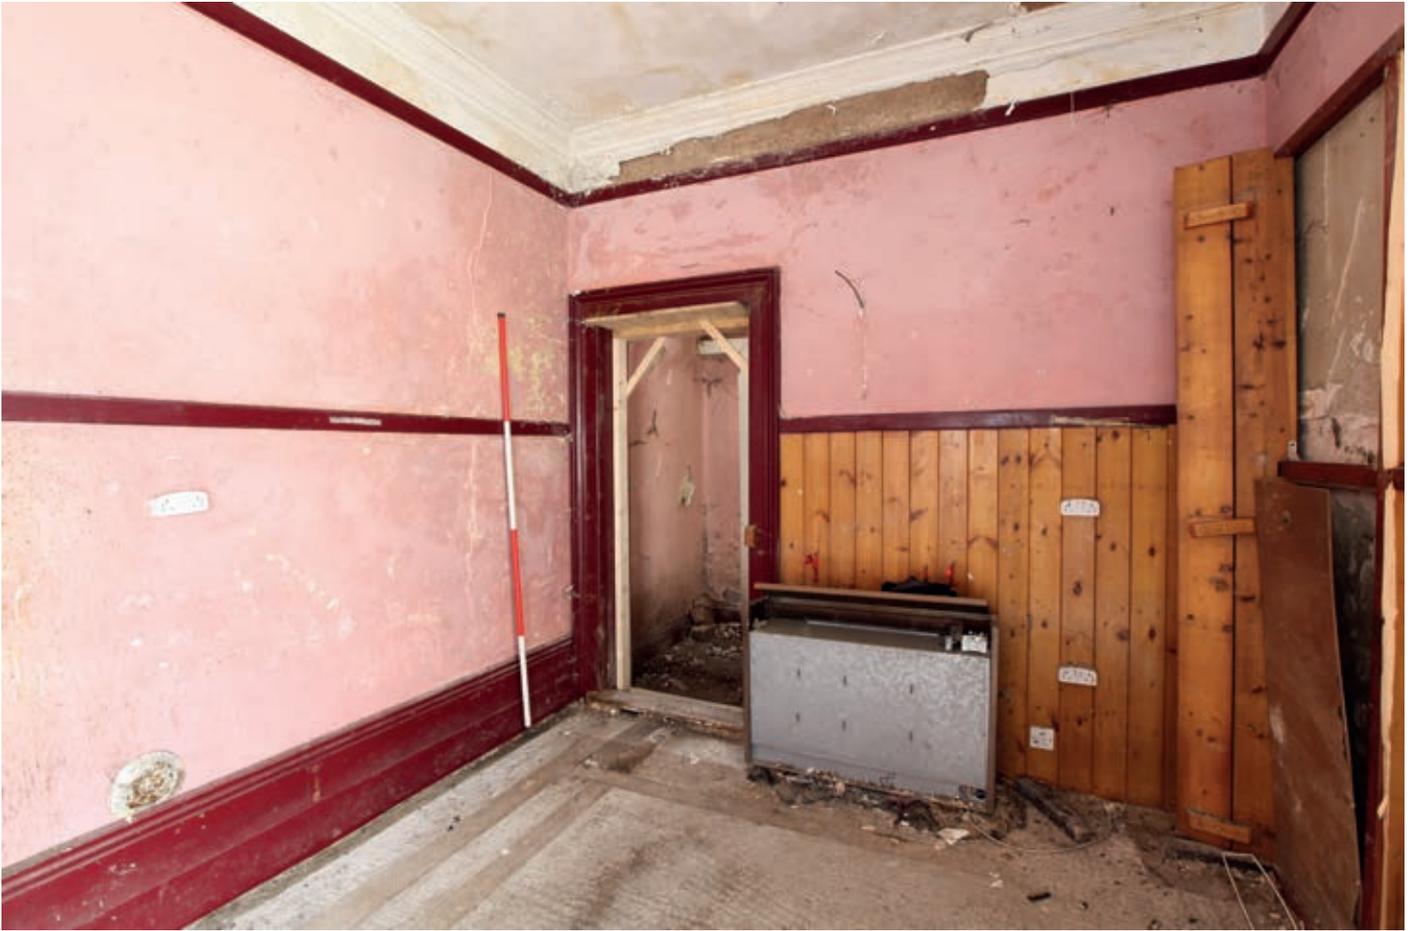
07_2 Ladies Waiting Room south elevation with east wall. Door architrave is a replacement. Early C20 rails and late C20 pine

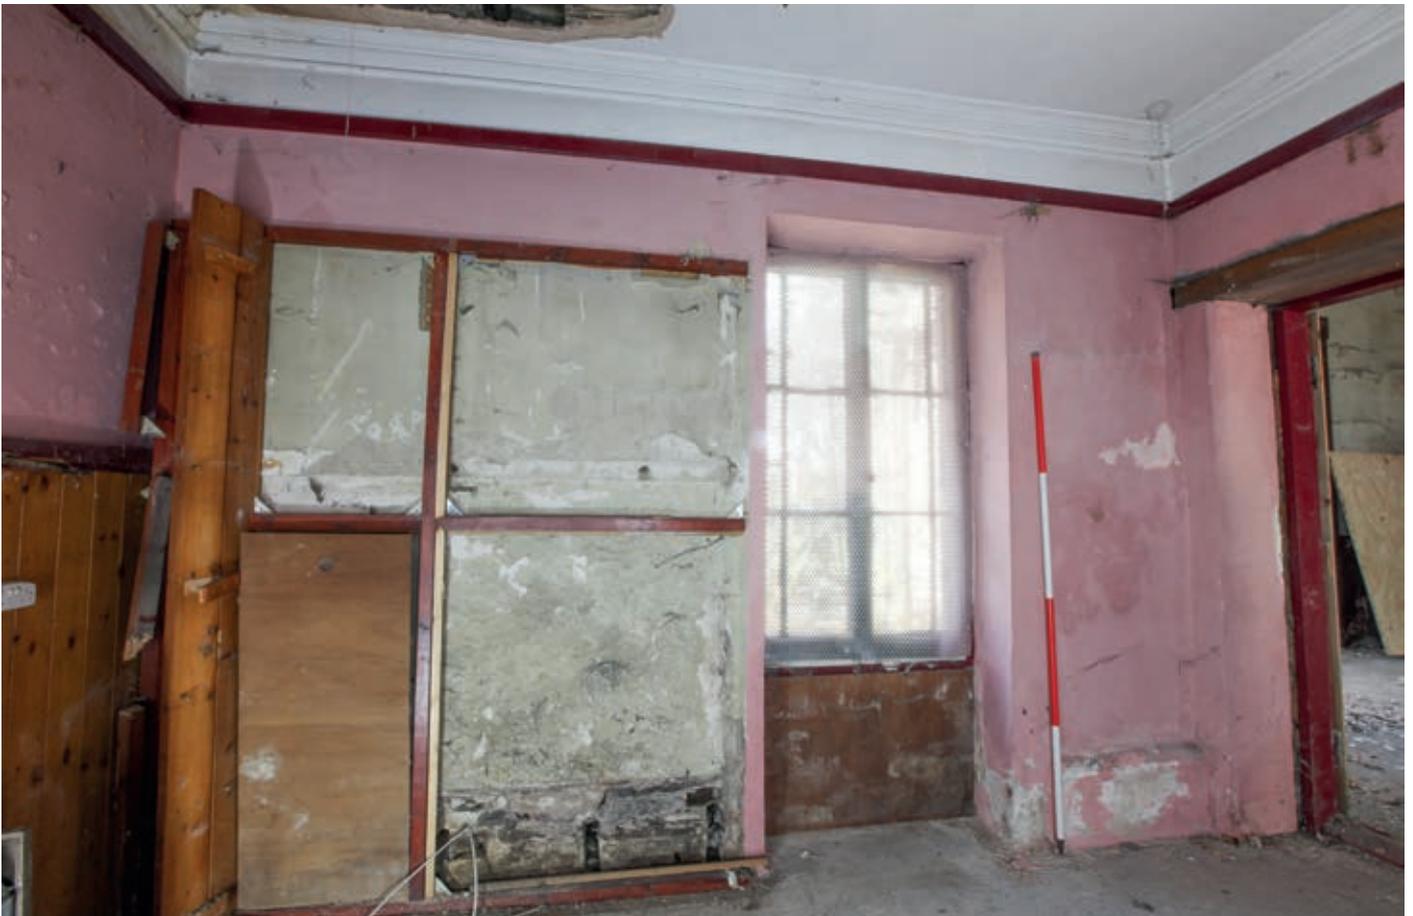
07_3 Ladies Waiting Room west internal elevation, with modified window reveal and later battens and late C20 panelling

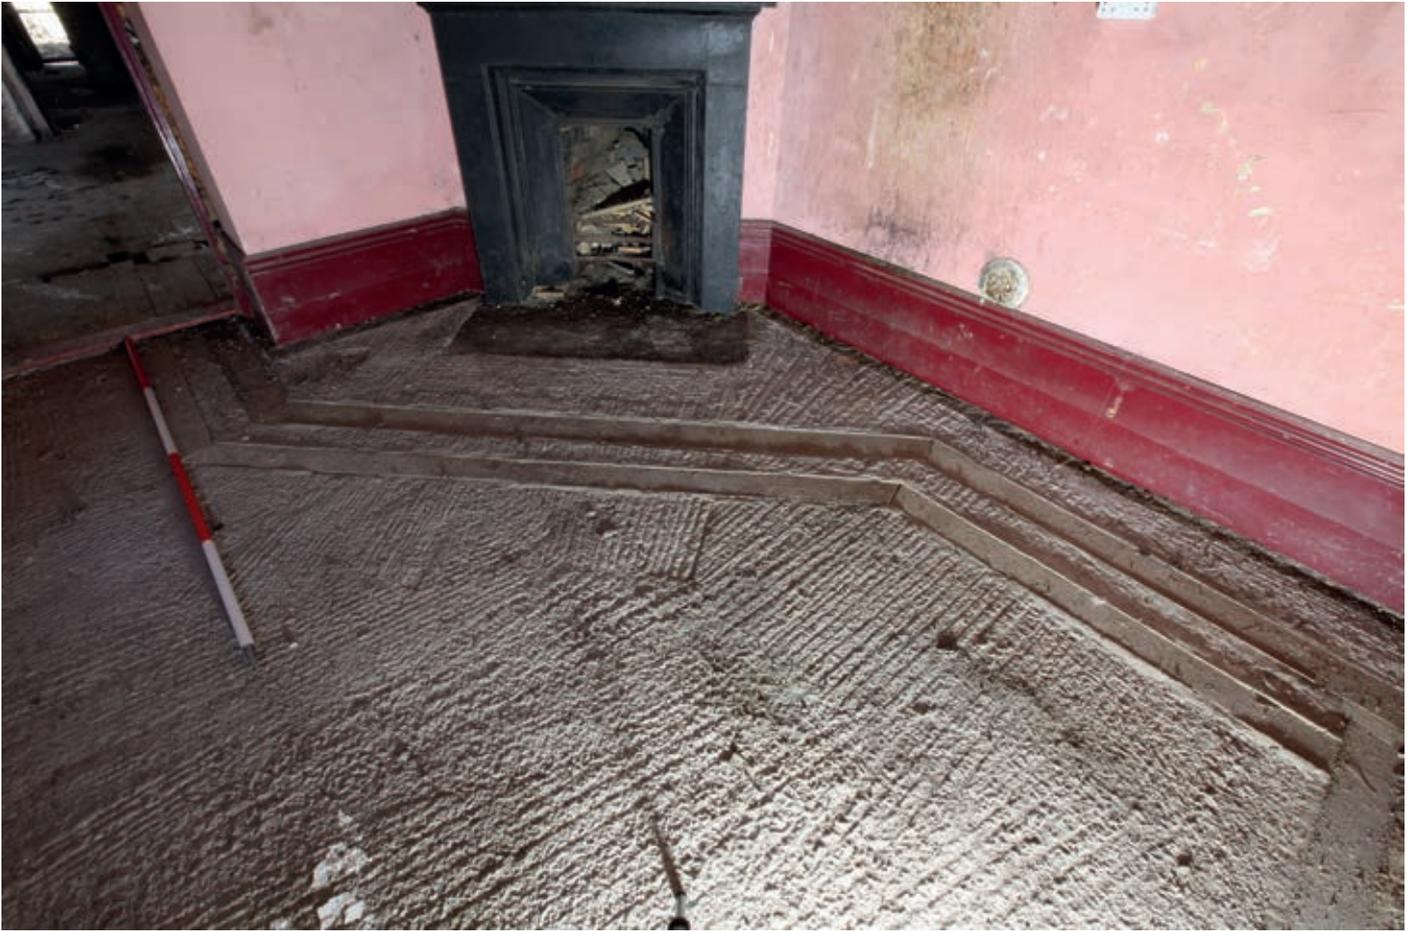
07_4 Ladies Waiting Room floor in concrete with cable channels, ca. 1970. The skirting is a replacement, based on the original size.

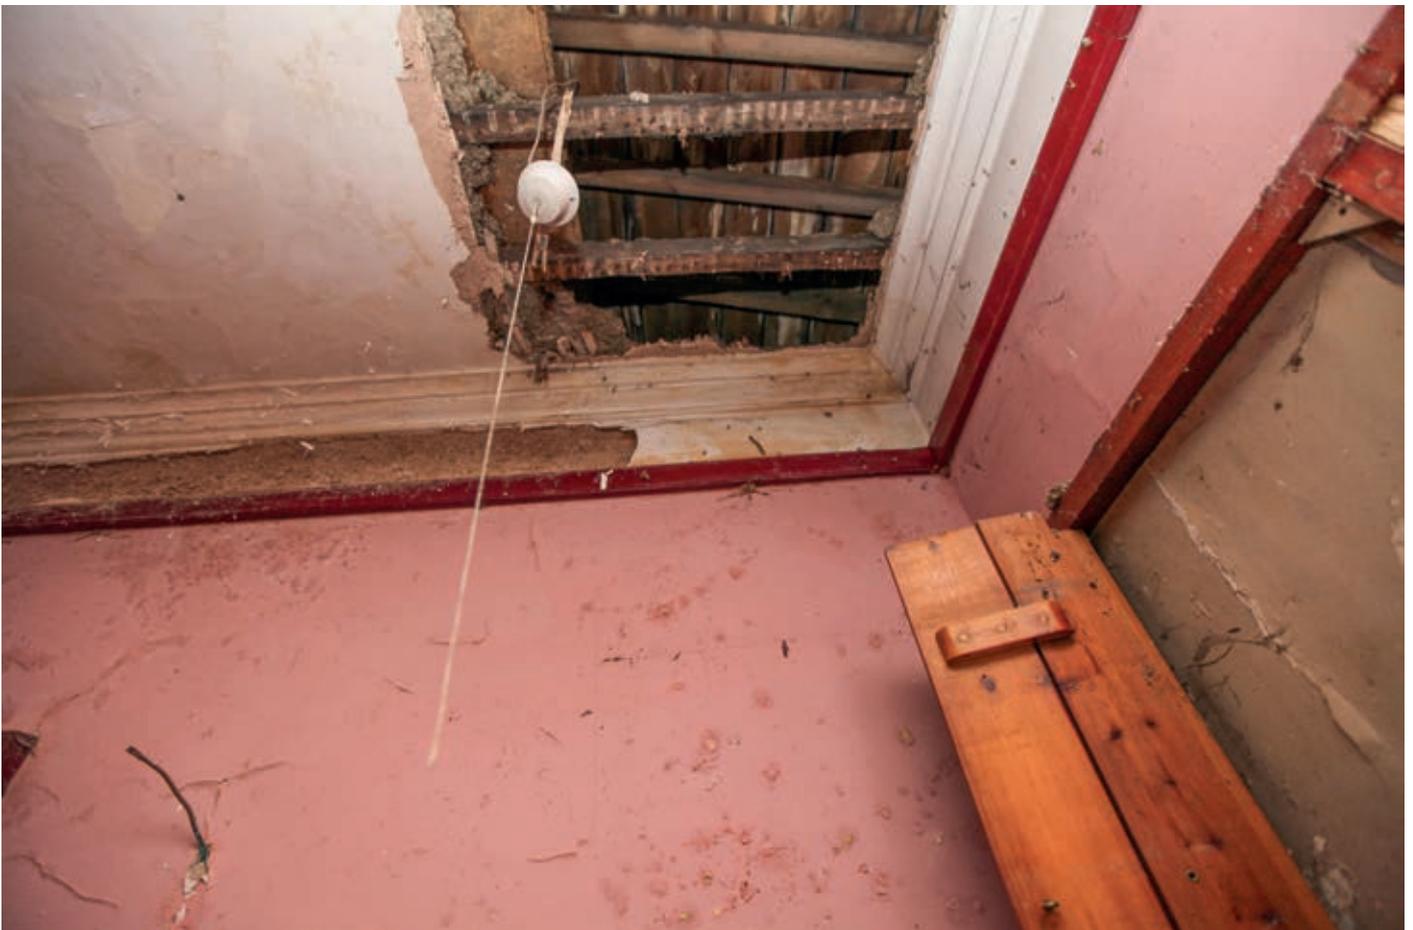
07_6 Ladies Waiting Room detail of cornice. The rails along the walls are 20th century.
