Wingfield Station Level 3 Historic Building Record

for Derbyshire Historic Building Trust

8th October 2021

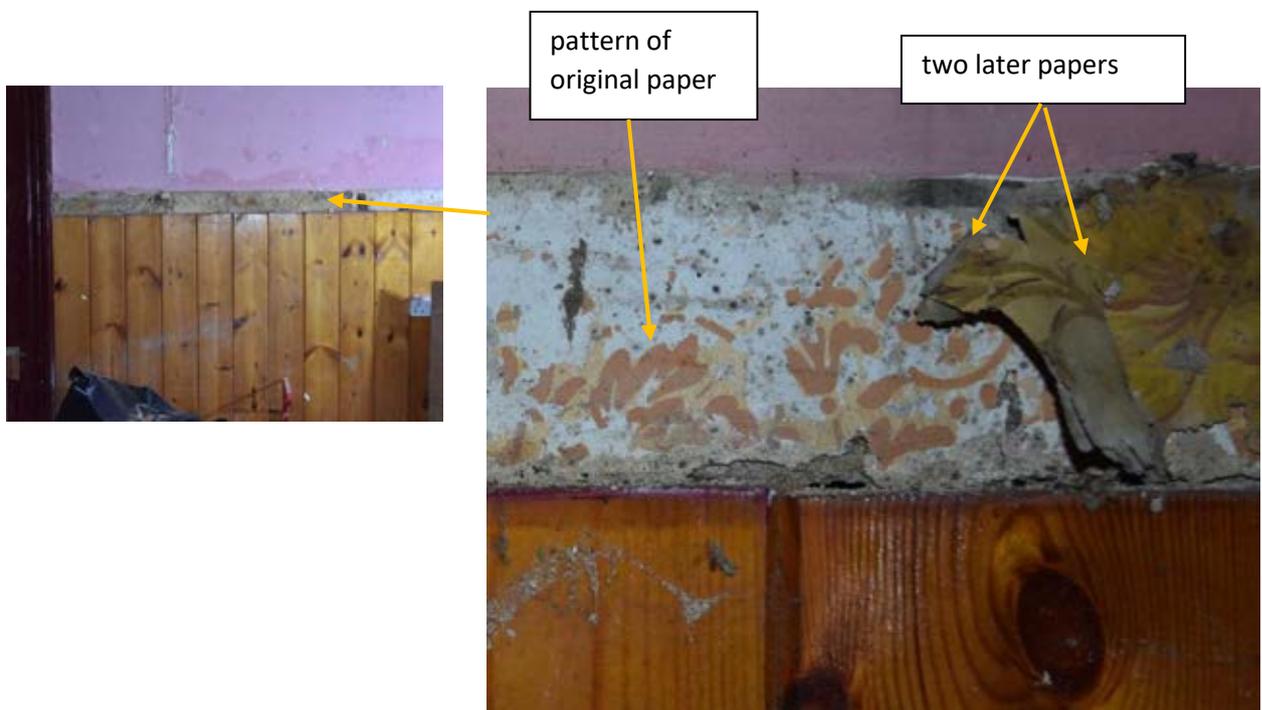
Printed wall paper was applied to the plaster walls. This was revealed when one of the later horizontal rails was removed.

The paper used was very thin, and glued directly to the plaster instead of to lining paper. It has now almost completely degraded, making it impossible to lift off a section. The paper was given a ground based on chalk which acted as the white background colour, followed by a floral motif executed in browns and yellows based on iron oxide pigments mixed with more chalk [Sample C21, p.34].
